## Abstract:

The 1985 Corvette manufactured by General Motors contained a beam in the driver's side door to resist penetration and protect the driver. The beam was supported by seven spot welds at the hinge in the door frame. During an accident, the welds were unable to withstand the proper load bearing and separated upon impact and indirectly caused the driver to sustain fatal head injuries. If the welds were properly joined the beam would have remained intact and would have been able to bear the load caused by the accident.

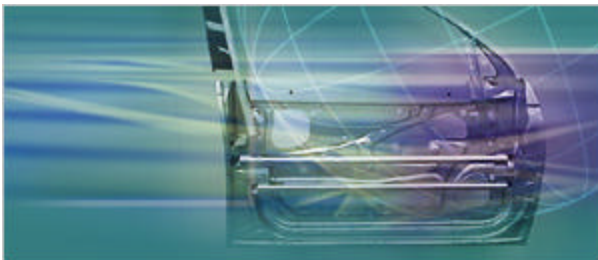
After an analysis of the car, it showed that the beam in the driver's side door had not remained intact during the accident. The high strength, low alloyed steel beam inside the door was used to increase rigidity and help buffer passengers from side impact (Figure 1). The beam was made to absorb a lot of energy and therefore reducing the amount of energy transferred to the occupants.

Figure 1: Side impact beams in the complete door frame.

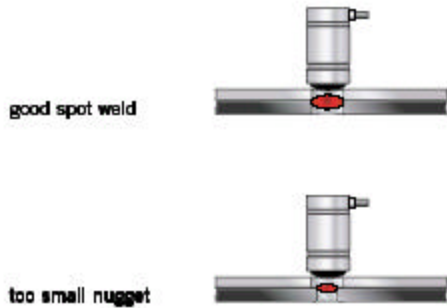
quality of the material to be welded. Production quality is determined by the porosity, penetration thickness, and the size (diameter) of the weld (Figure 3).

Figure 3: Good weld vs. defective weld

The defective spot welds in the door of the Corvette should have been prevented with proper inspection. Systematic testing of spot welds assist in the assurance of quality. This has been carried out using a hammer and chisel and performing tension-shear, cross tension, twist, and peel tests on randomly selected welds (Figure 4). The nuggets (welds) were extracted and the defects were spotted using the trained eye. This was time consuming and expensive because the part was unable to go to market once it was tested.
