Abstract:

Introduction:

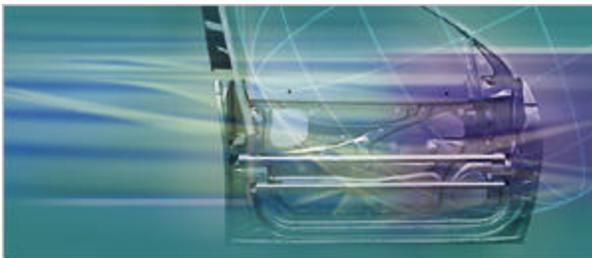
After an analysis of the car, it showed that the beam in the driver's side door had not remained intact during the accident. The high strength, low alloyed steel beam inside the door was used to increase rigidity and help buffer passengers from side impact (Figure 1). The beam was made to absorb a lot of energy and therefore reducing the amount of energy transferred to the occupants.

Figure 1: Side impact beams in the complete door frame.

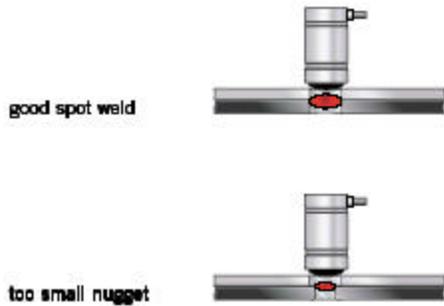
quality of the material to be welded. Production quality is determined by the porosity, penetration thickness, and the size (diameter) of the weld (Figure 3).

Figure 3: Good weld vs. defective weld
