Abstract:

Introduction:

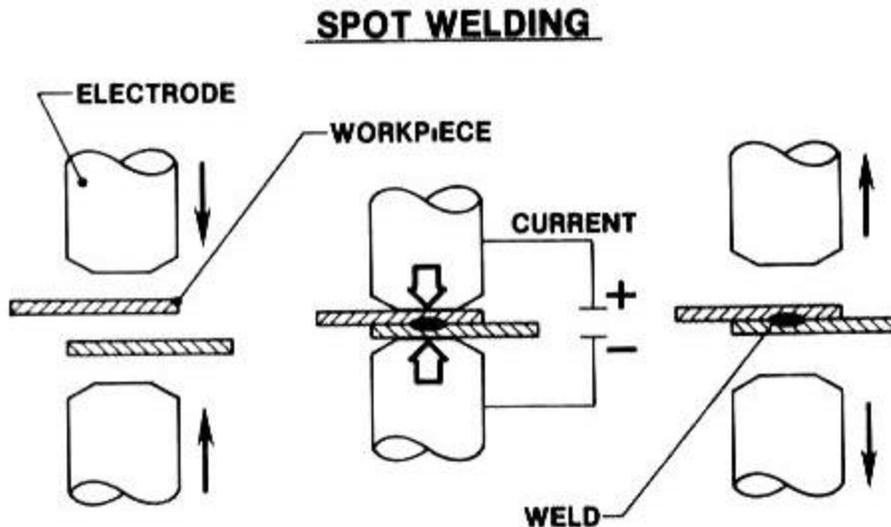
Figure 2: Spot welding Process

than that of the electrodes causing heat to generate and thereby melting the material. The pressure on the electrodes forces the melted material in the two pieces of metal to unite and the pressure is held constant after the current stops flowing long enough for the metal to solidify (Figure 2).

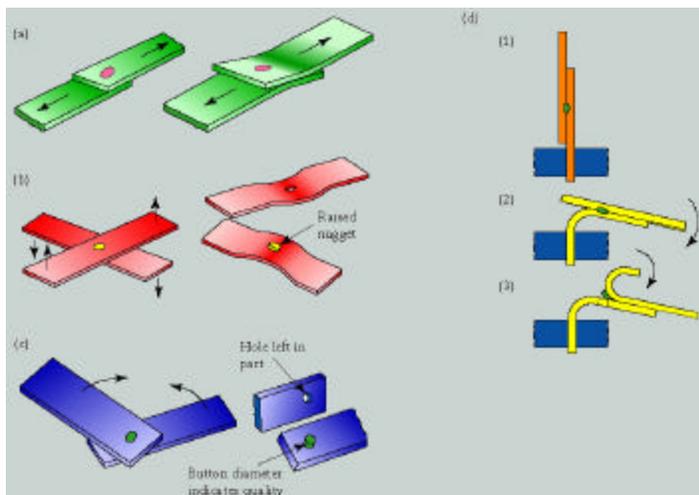
Figure 4: Tension-shear test for spot welds. (b) Cross-tension test. (c) Twist test. (d) Peel test.

The defective spot welds in the door of the Corvette should have been prevented with proper inspection. Systematic testing of spot welds assist in the assurance of quality. This has been carried out using a hammer and chisel and performing tension-shear, cross tension, twist, and peel tests on randomly selected welds (Figure 4). The nuggets (welds) were extracted and the defects were spotted using the trained eye. This was time consuming and expensive because the part was unable to go to market once it was tested.

In 1989 (after the manufacturing of the 1985 corvette) a new ultrasonic form of testing was made available. This method is based on the different intensities of the sound wave energies traveling through the weld. This is a nondestructive form of testing which allowed the part to go to market after it was tested. This test can detect the porosity, size, and penetration depth of the weld and is very accurate. If this test was available and properly used in the production of the 1985 corvette, the accident could have greater probability of being prevented.

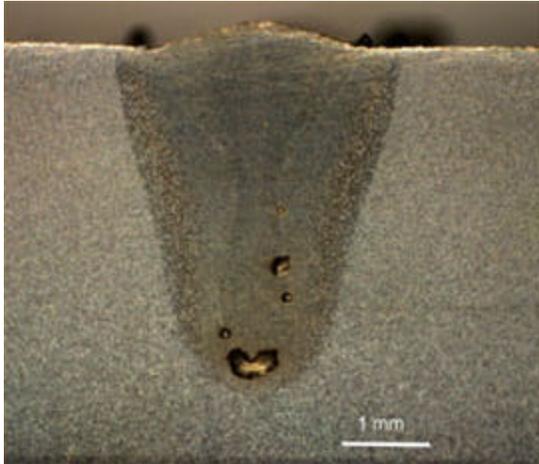
Figure 5: Laser weld

minimal heat input while running at high welding rates (Figure 5). Because the weld is so small, there is no need for surface finishing and this further reduces costs.

Laser welding proves to be a great alternative to spot welding. With laser welding, there are no uncertainties about corrosive electrode tips, variance of surface quality of the welding material, or the quality of the electrical contact.
